## GMT800 A Pillar Clip Repair Install Instructions

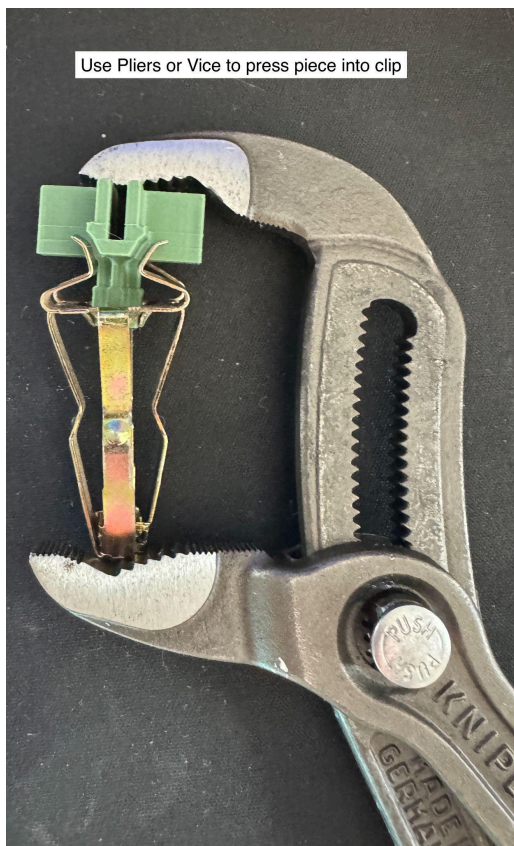
Step 3: Spread the Center portion of the metal clip out enough to where the tip of the repair clips goes in without too much resistance. You still want the bottom half to have some resistance to keep the clip from being too loose. Note: Red Circle on Image!

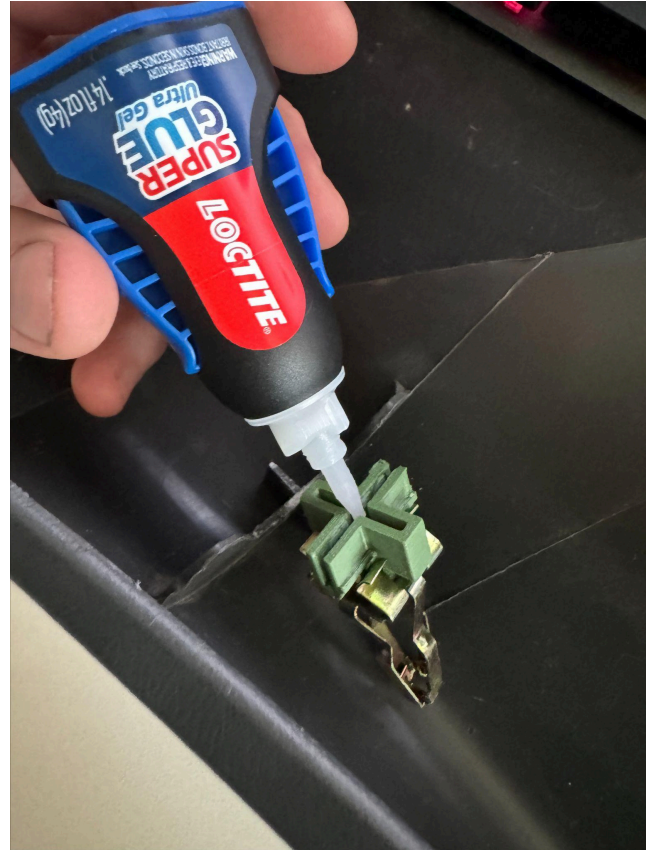
Step 5: Glue center of Repair Bracket with epoxy or super glue to bond the clip to the plastic. Secure the clip to the A Pillar and let glue cure for best results!

For future removal I found super glue to hold fine but not melt to the plastic if you plan to remove the clip in the future. Hope these instructions help and reach out if you have any questions or run into any issues!
